GEOTECHNICAL RECONNAISSANCE REPORT

PLAZA CAMINO REAL SHOPPING CENTER REVITALIZATION CARLSBAD, CALIFORNIA

GEOCON
INCORPORATED

**JANUARY 28, 2010
PROJECT NO. G1180-32-01**

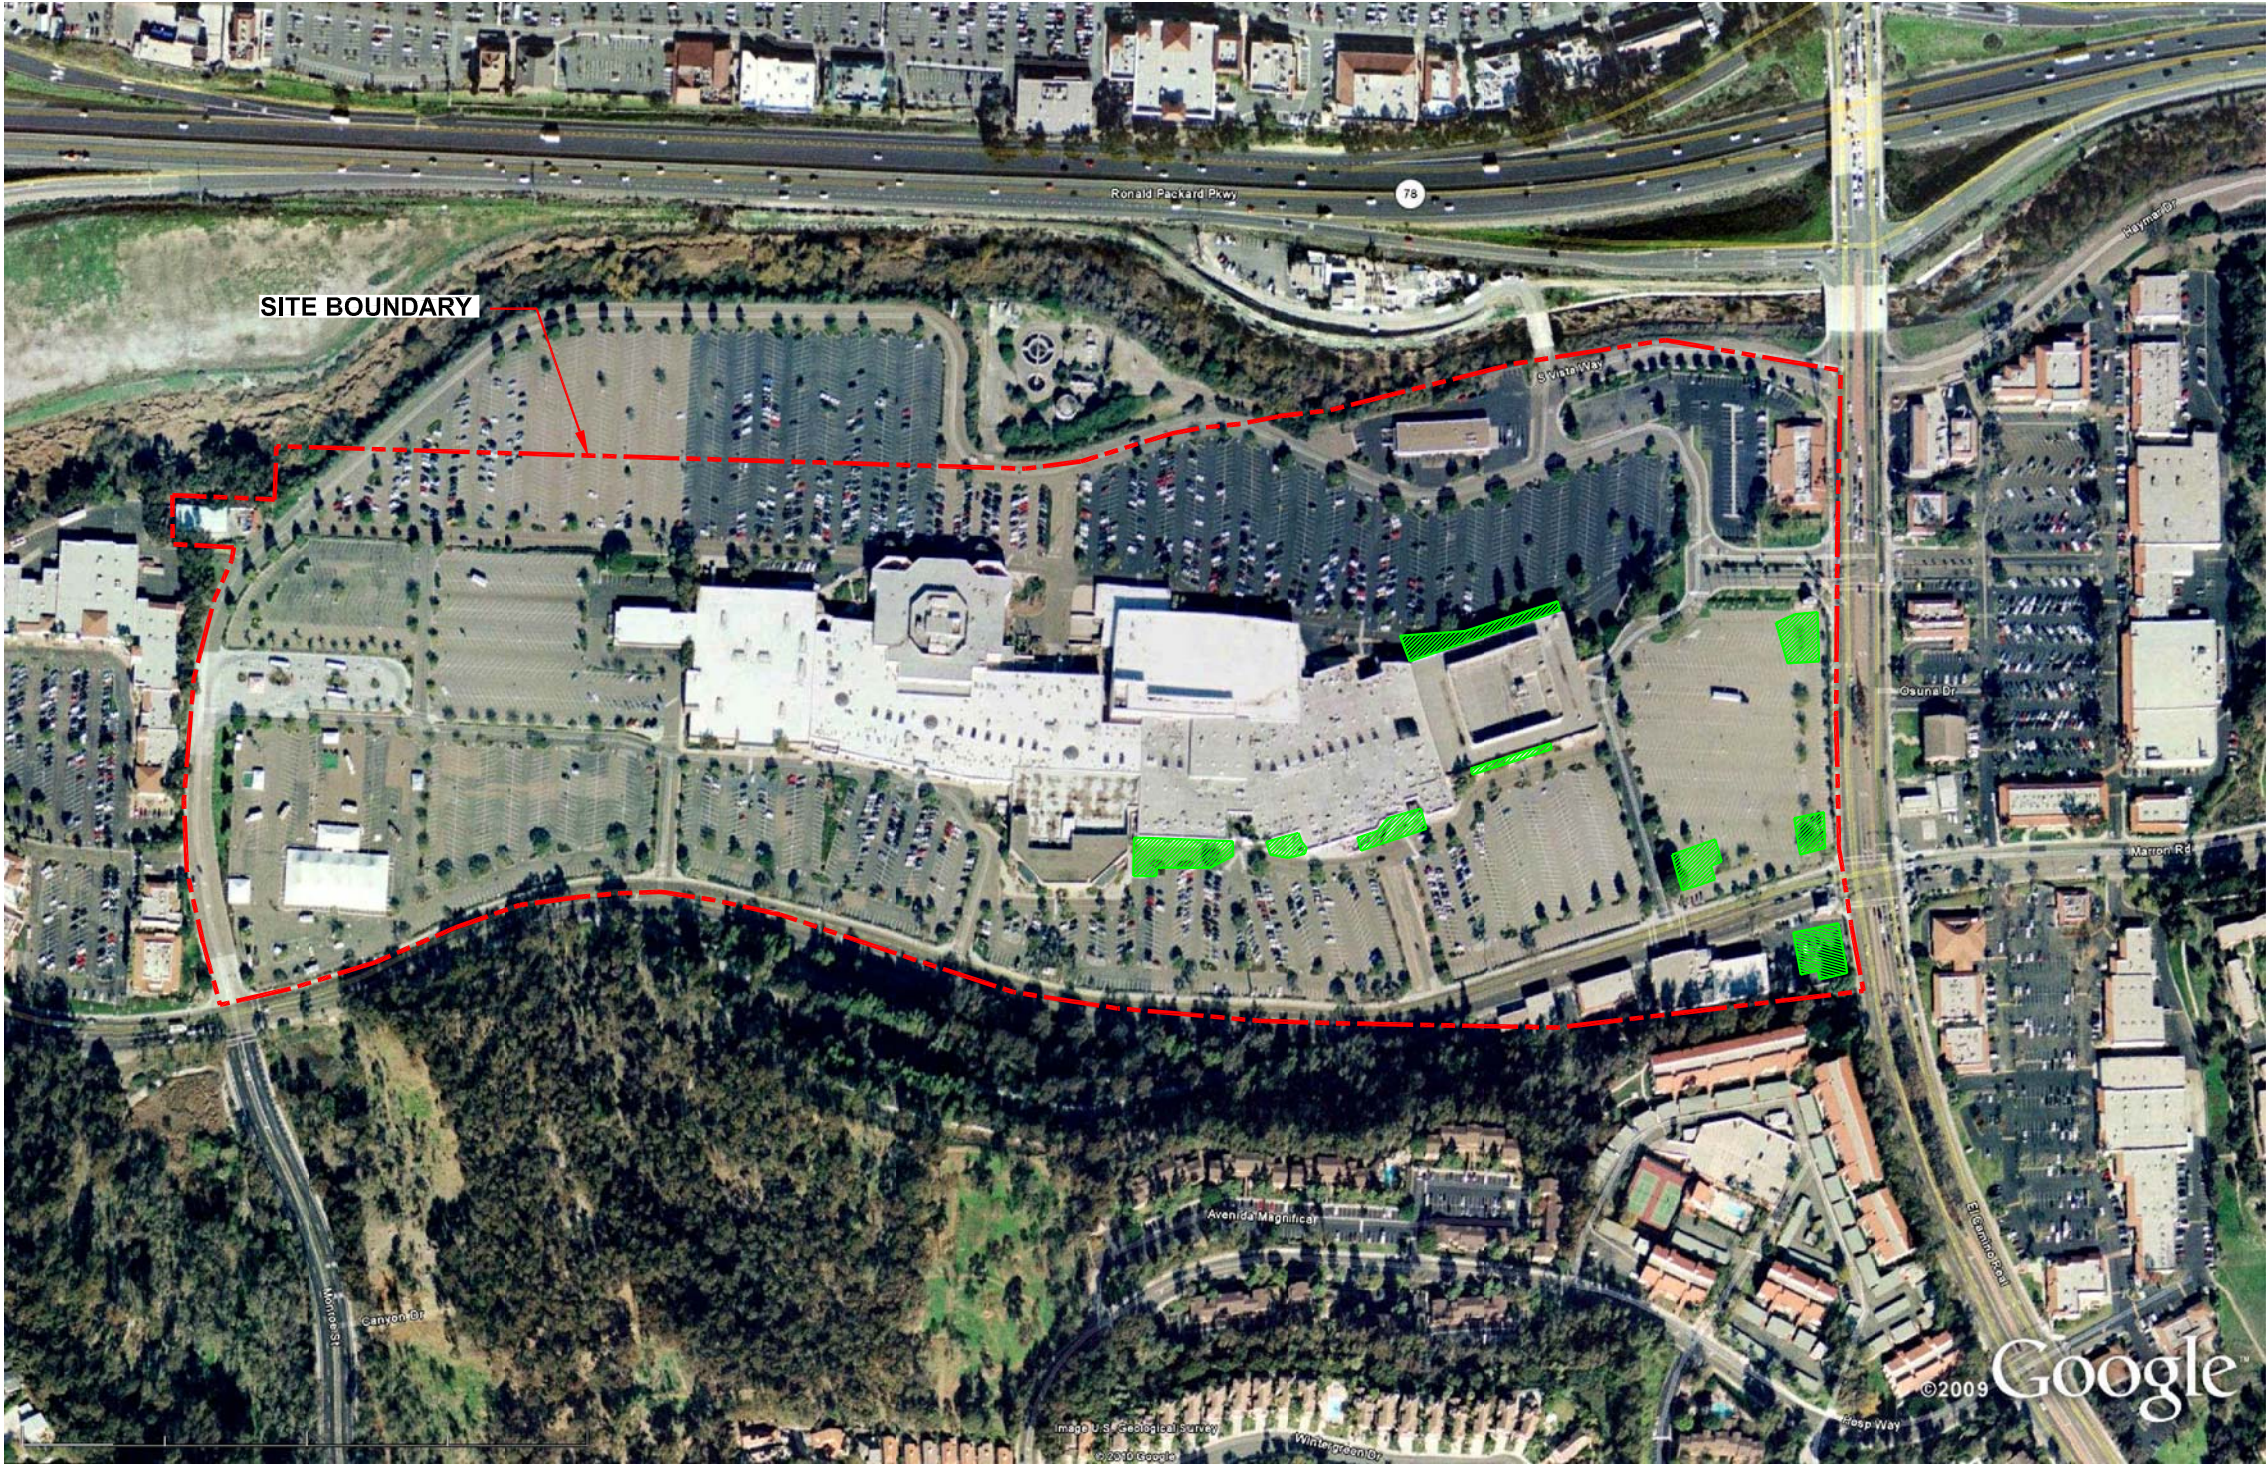
SITE PLAN

The Site Plan (Figure 2), which utilized a Google Earth image as the base map, depicts the current configuration of the subject property and existing improvements. We added the approximate overall project limits and locations of proposed improvements.

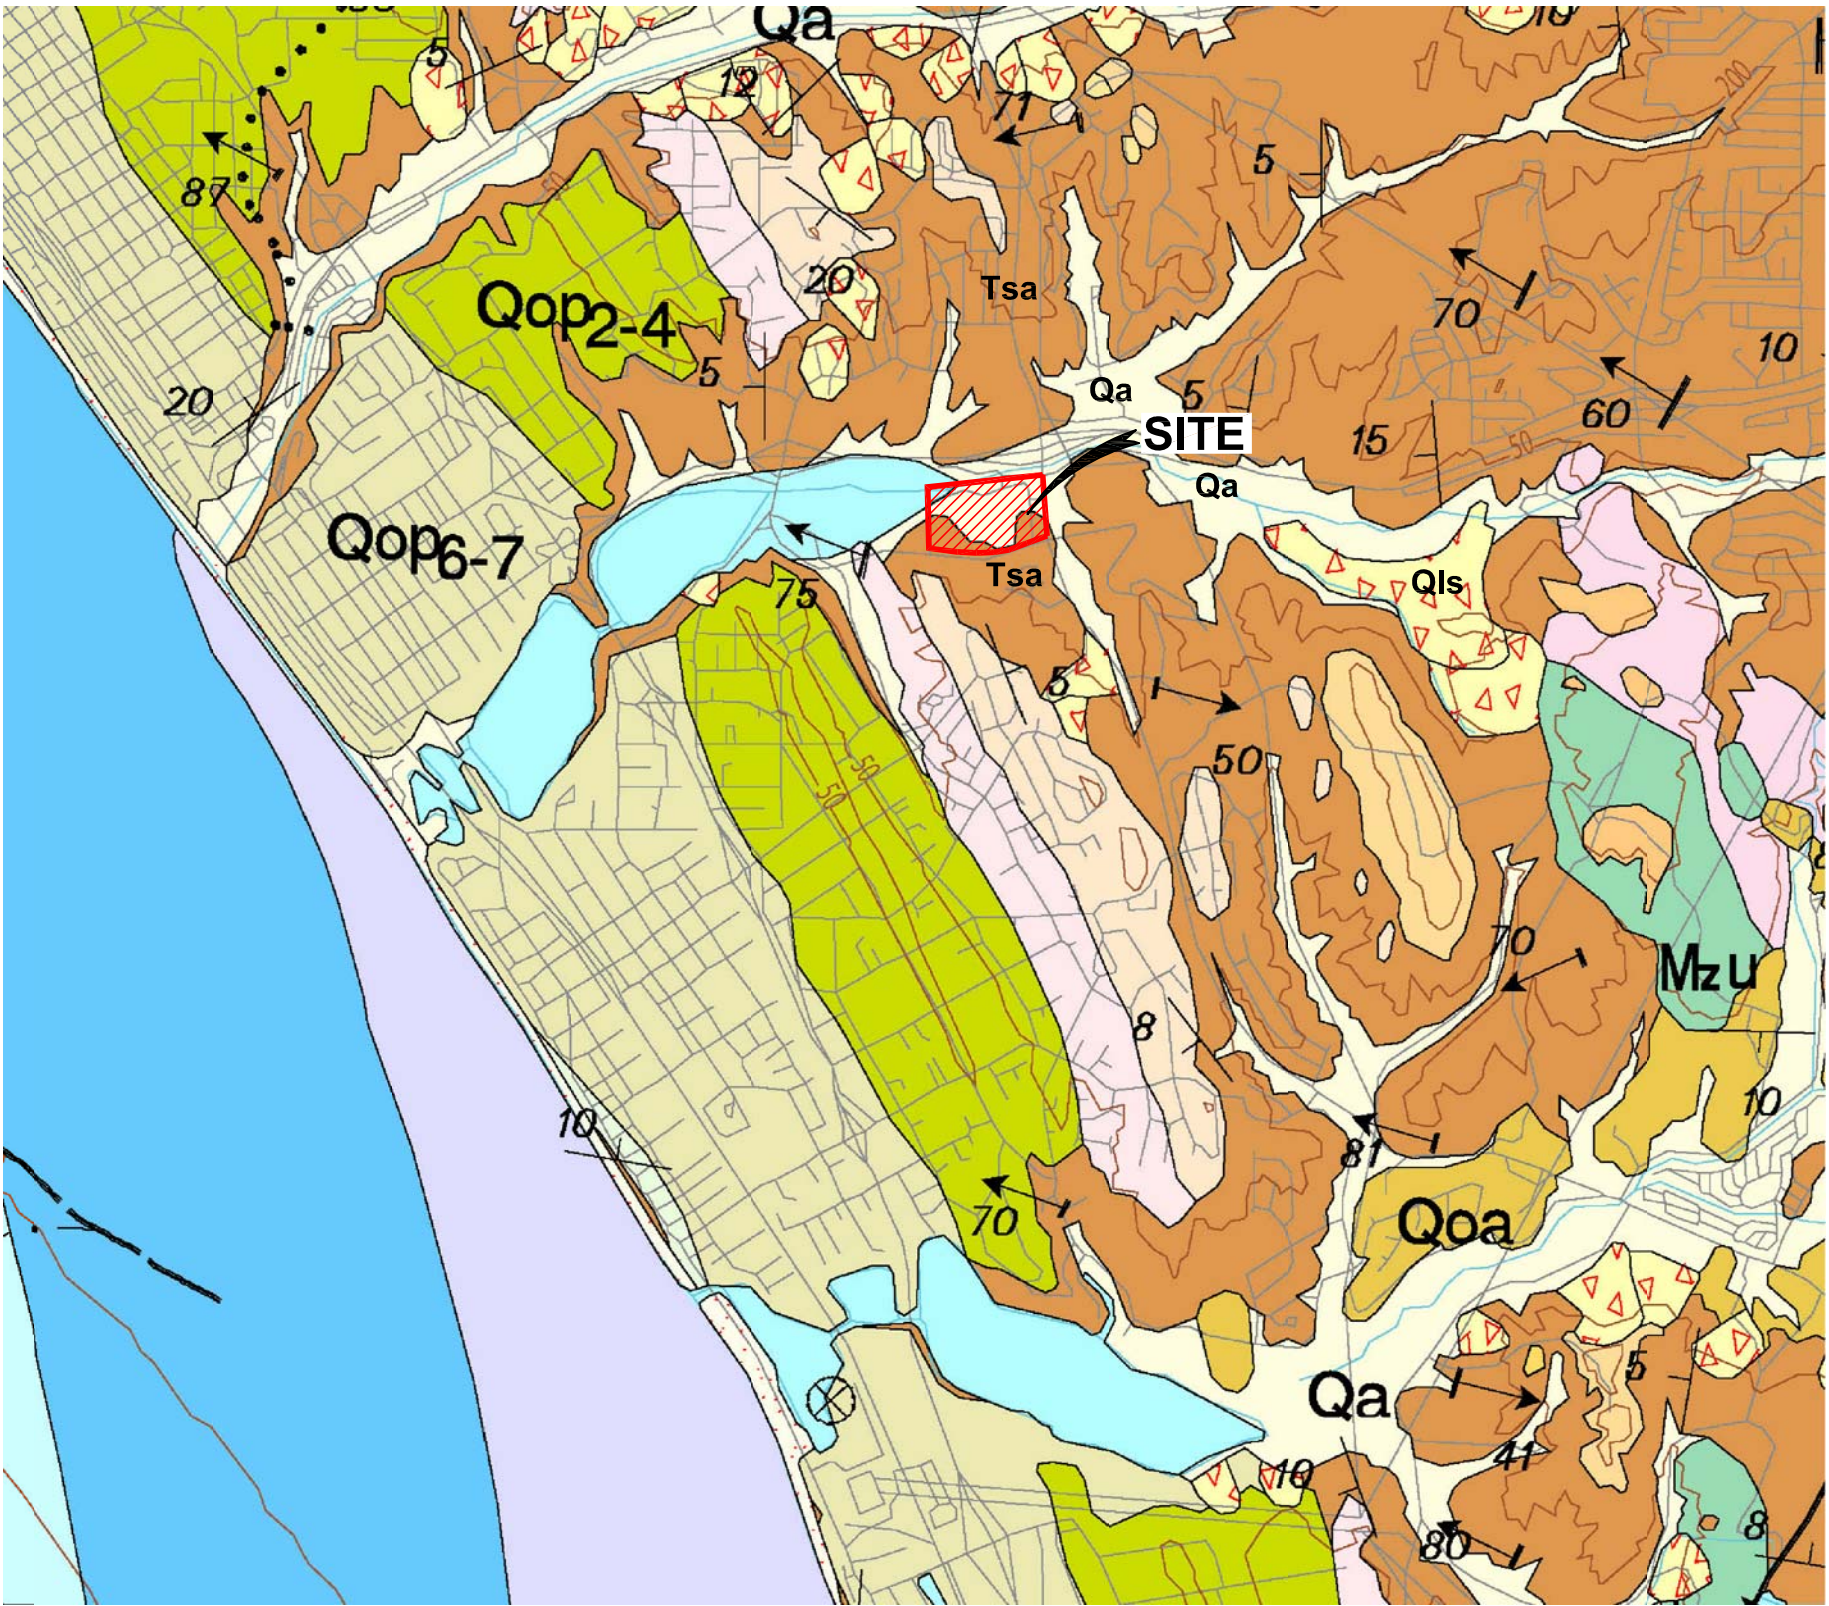
REGIONAL GEOLOGIC MAP

(Blake, 2000) was utilized. In addition to fault location, *EQFAULT* was used to estimate ground accelerations at the site for the maximum anticipated seismic event. Regional geologic information (Reference No. 5) is presented in Figure 3.

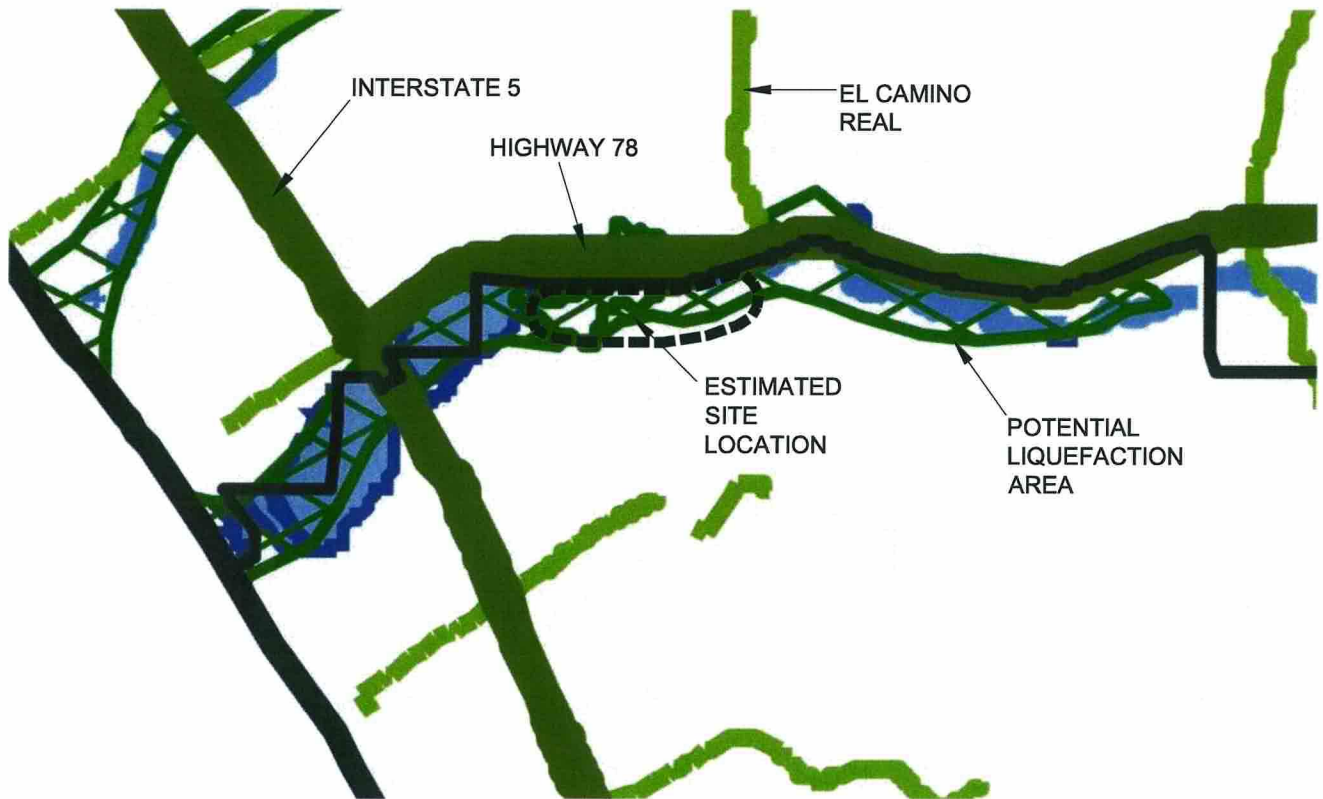
LIQUEFACTION HAZARD MAP

The County of San Diego Hazard Mitigation Plan maps identify zones of high risk for liquefaction in areas throughout the county. The northern portion of the subject property is included in a high-risk hazard area based on their mapping. The potential for liquefaction and seismically induced settlement occurring within the site will be a primary focus of future studies.

In accordance with your request, we have prepared this addendum to our report entitled *Geotechnical Reconnaissance Report, Plaza Camino Real Shopping Center Revitalization, Carlsbad, California*, dated January 28, 2010. The addendum, Figure 4 attached, is a site plan presenting the estimated project location on an enlarged version of the map entitled *County of San Diego, Office of Emergency Services, Multi-Jurisdictional Hazard Mitigation Plan, 2010 (Draft)*.
